1. Stamford Sewer before rehabilitation

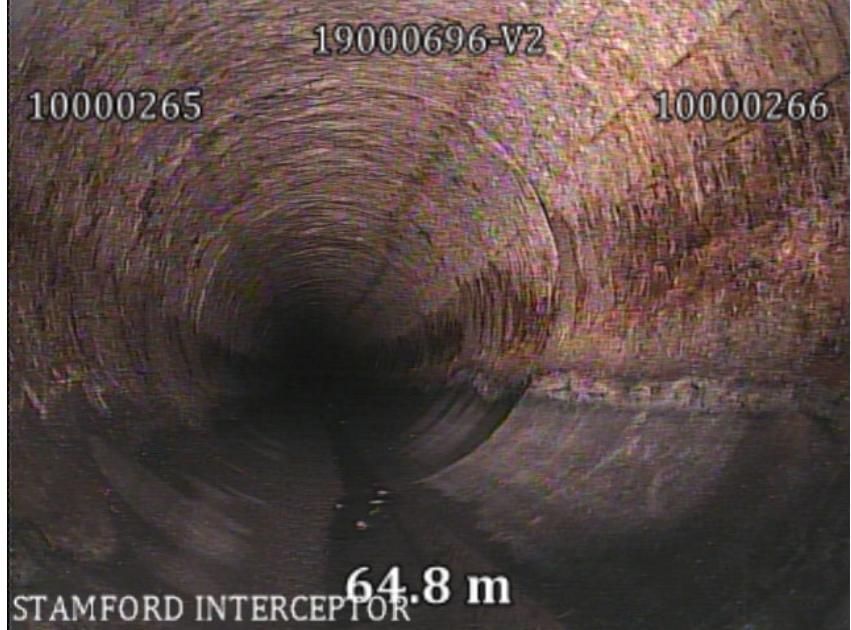
Hydrogen Sulfide gases have deteriorated the concrete in the sewer thus exposing and attacking the rebar reinforcement.

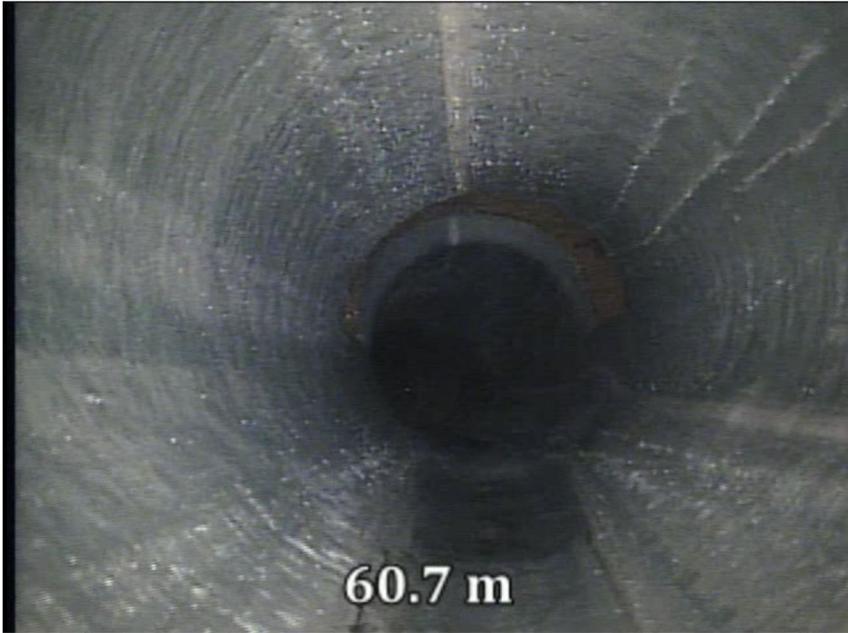
2. Stamford Sewer after rehabilitation

Sewer interior has been protected with a fully structural Cured-In-Place-Pipe (CIPP) liner.

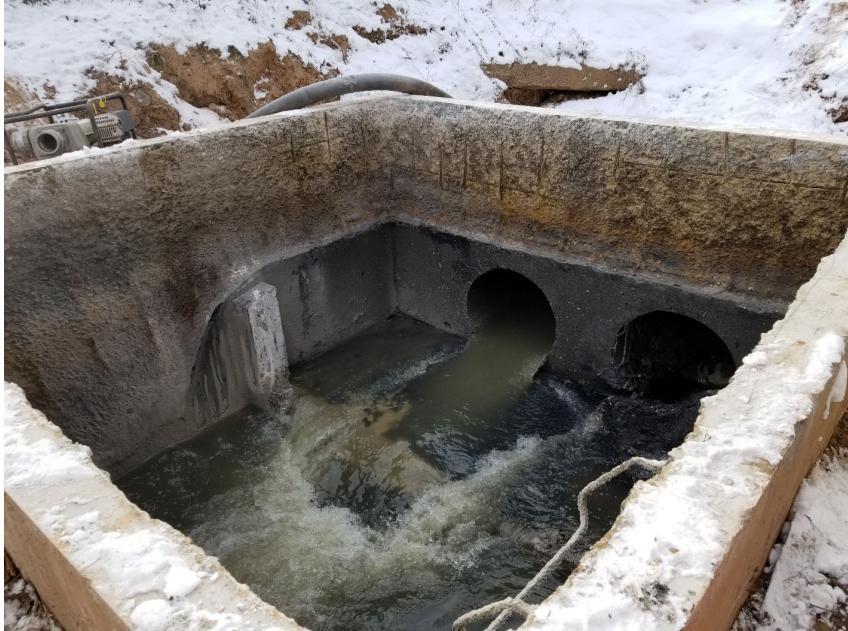
3. Stamford Sewer manhole before rehabilitation

Hydrogen Sulfide gases have deteriorated the concrete in the manhole above sewage levels thus exposing and attacking the rebar reinforcement.

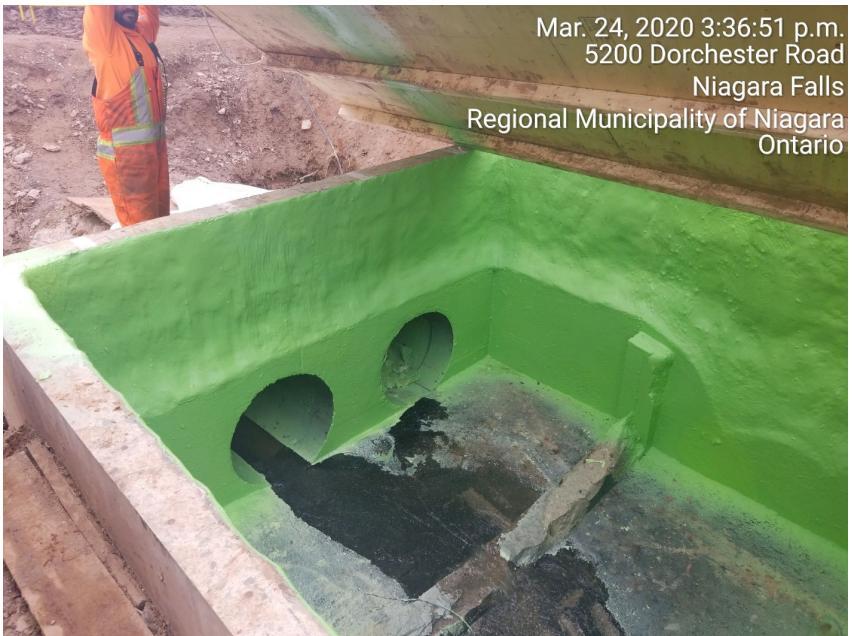
4. Stamford Sewer manhole after rehabilitation

Manholes are cleaned with high pressure water, parged with a cementitious coating and then covered in a spray applied epoxy coating. This protects the manholes from further deterioration due to hydrogen sulphide gases.

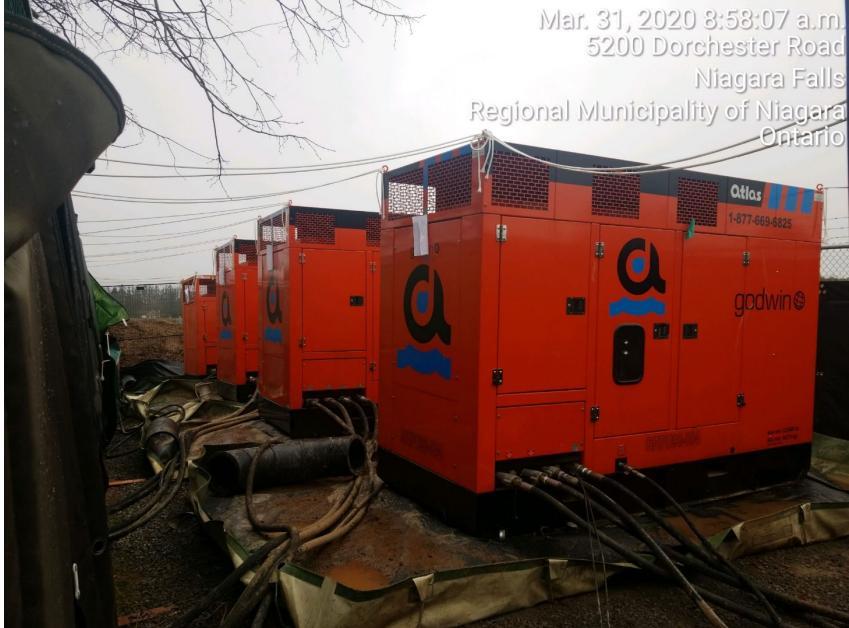
5. Complex Bypass Pumping Systems

Complex bypass systems are installed upstream of the project to divert the sewage around the project site. CIPP Installations require dry working conditions.

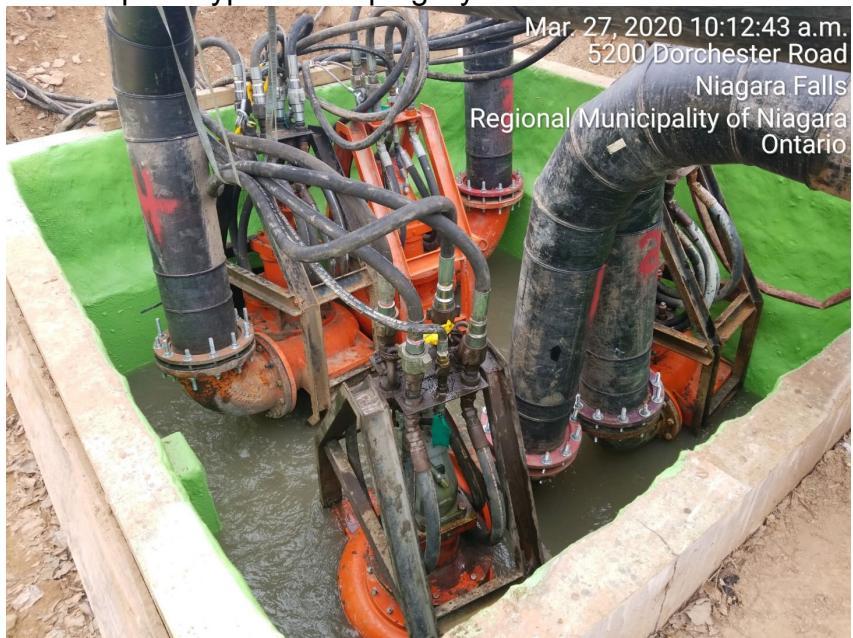
6. Complex Bypass Pumping Systems

Complex bypass systems are installed upstream of the project to divert the sewage around the project site. For Stamford Phase I, four (4) large submersible pumps were used to maintain sewage flows.

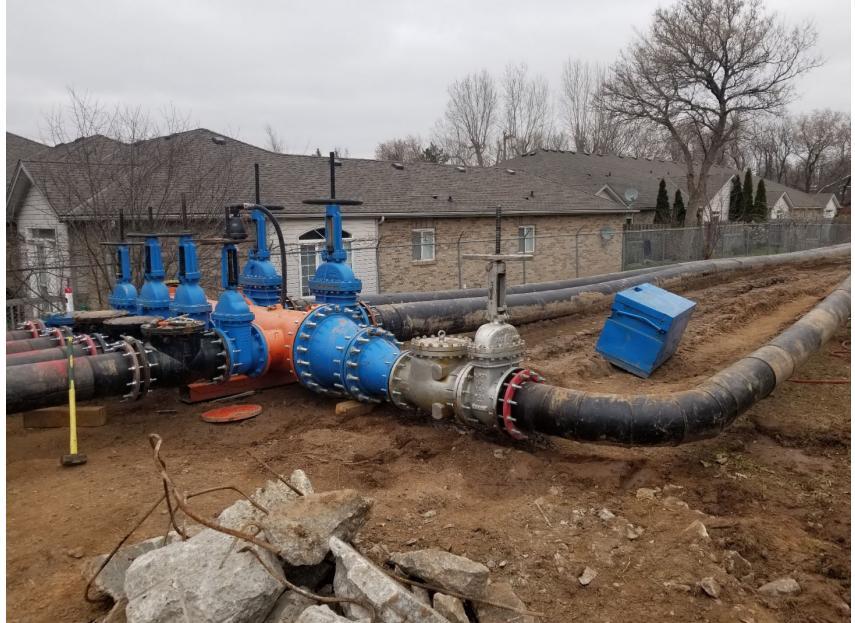
7. Complex Bypass Piping Systems

Complex bypass piping systems are installed to carry the flows from the bypass pumps to a discharge point downstream of the project site approximately two (2) kilometers away.

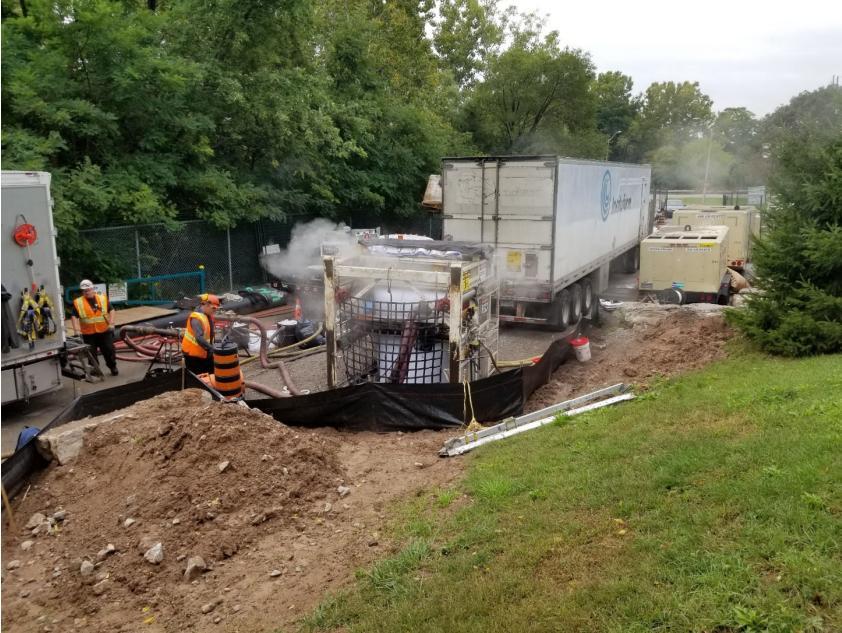
8. Cured-in-place pipe liner installation

Stamford Sewer Rehabilitation is completed by inverting a resin impregnated felt tube liner into the sewer and curing it with steam.
